Thermographic and Optical Wind Blade Inspection

for extended availability at minimal risks

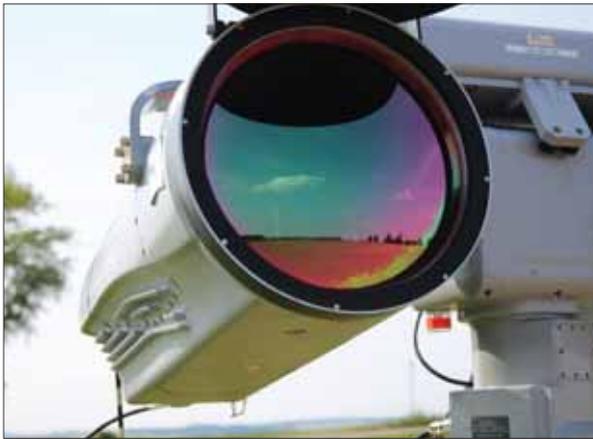
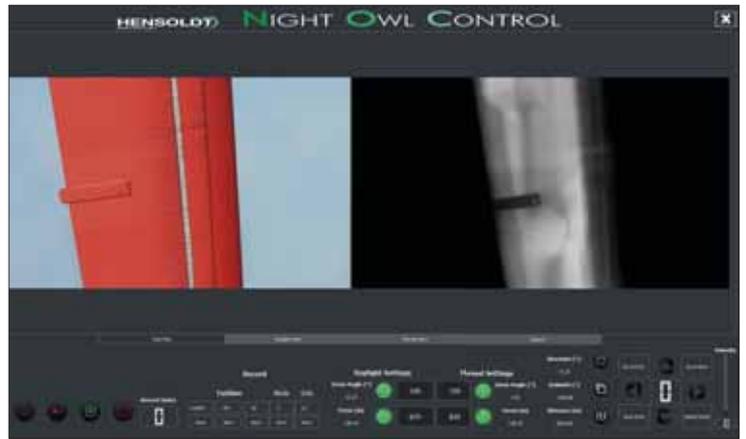
Ground-based thermographic inspections

Solar energy is the only energy source used, meaning that no additional heating sources are required.

The optical and thermal camera system is placed on the ground at a distance of 100 to 200 metres from the turbine, eliminating any HSE risks and avoiding collateral damages due to rope access.

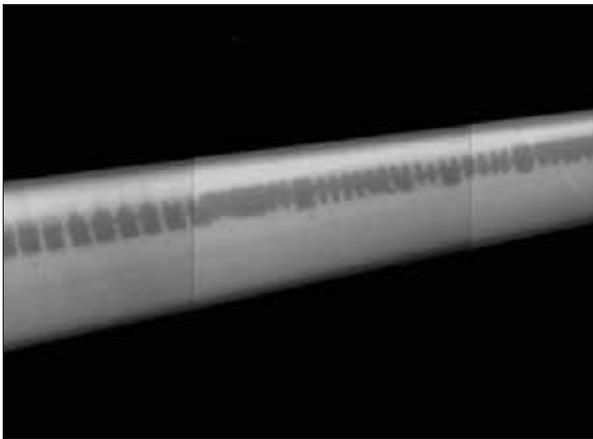
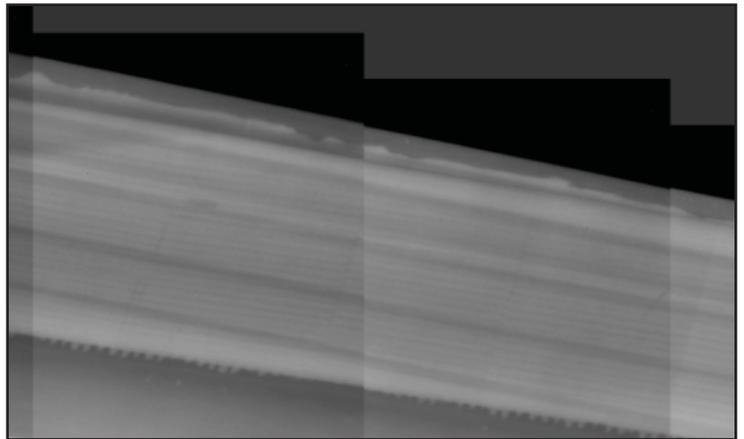
Structural blade analysis

Both optical and thermal imaging technologies have unique benefits. The combination of both technologies is required to achieve the best quality for composite inspection and to detect a wider range of flaws on the outside and inside of the wind blade.
